**Flood Control Project Maintenance
Levee Inspections**
LMA District Cover Sheet
Spring 2020 Levee Inspection Results

Sutter Maintenance Yard East Levee Sacramento River

Spring 2020 Levee Inspection Results

| Waterway | | | Bank | Unit Miles |
|--|---|---|---|---|
| Unit No. 01 Sacramento River | | | Left | 19.85 |

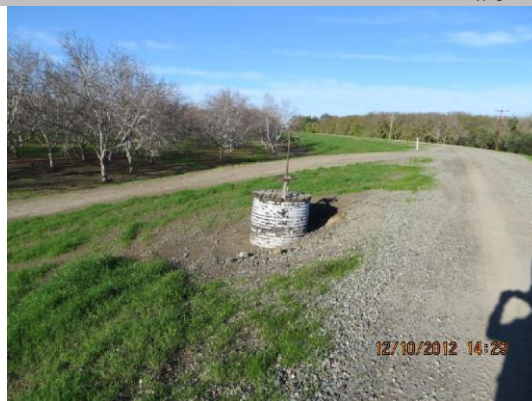
Photo 1 of 3 : UCIP_SP_2020_56035_47336.jpg

DS_ID:17369
FS_ID:56035
EP_NO: 9510
Repair Type: Non-Urgent
Crossing Status: Found
UCIP Comments: 08/01/2019 Record has been downgraded from Urgent to Non-Urgent due to the proximity of the erosion present on the WS. Erosion at the surge box is still present (located away from WS toe). Recommend auditing this record to determine if ABO issued as permit number 9510 authorizes all appurtenances associated with this structure. Need to owner to address the erosion on WS toe. (O. Magana - DWR UCIP)08/30/2018 Same as last inspection; erosion at surge box so crossing remains Urgent (D. Sanoski - DWR UCIP).04/20/2017 Erosion hole at WS surge box has gotten worse after the Jan/Feb 2017 high water event. Pipe also leaked which is believed to be caused by the screw gate not fully closing. (DWR Sutter Yard- AFreitag)10/31/2016 No repairs have been made here yet. Bad erosion still present at the WS toe distribution box.(DWR Sutter Yard- AFreitag)06/03/2016 Bad erosion still present all around the WS surge box. Pipes were flowing water at the time of inspection and the bottom of the erosion hole was wet and had standing water in it indicating a leak coming from the surge box. (DWR Sutter Yard - afreitag)04/14/2016 Heavy scour still present around surge box on WS exposing pipe. Levee caved in and severely damaged around surge box. Erosion around CMP riser on WS cited previously not found. (DWR UCIP - kfazel)04/02/2015 Pipe leaks during high water. It is suspected that the screw gate does not fully close and may need to be cleaned to allow it to close fully. (DWR Sutter Yard - afreitag)07/02/2014 Same as last inspection. (DWR Sutter Yard - afreitag)12/19/2013 Same as last inspection. (DWR Sutter Yard - afreitag)07/23/2013 Water was flowing from the WS to LS ditch. Not sure where water flow was originating. All erosion problems are still present. (DWR Sutter Yard - afreitag)12/10/2016 Soil erosion around CMP riser and surge concrete box on WS damaged due to overflow. Pump not found. Flap gate missing on WS concrete box. WS slope eroded. Structure might have been used as drainage structure. This needs to be determined during routine inspection. (DWR UCIP - pamatya)

FIELD_STRUCT_DESC: 36-inch corrugated metal irrigation pipe through the levee, 18 feet below the crown. Slide gate in a 48-inch corrugated metal pipe (CMP) riser on the waterside (WS) slope. Concrete box on the WS. Pump mounted on the WS bank, not found in 2016. (Automatic Board Order (ABO) issued as Permit No. 9510, 1974 - Forry). [Additional Reference(s): DWR Levee Log, 2002. USACE Sacramento O&M Manual 136, March 1960 (HLM 12.95)].
FS Date: 8/1/2019 1:49:00 PM

WS view: CMP riser on levee slope.

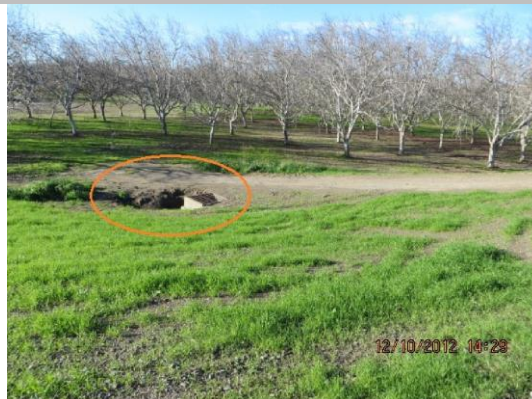
Photo 2 of 3 : UCIP_SP_2020_56035_47334.jpg

WS view: overview of concrete surge box

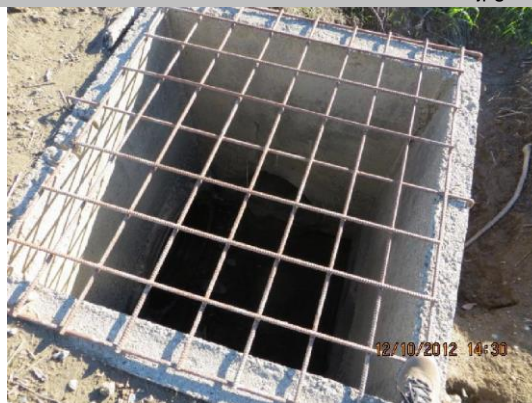
Photo 3 of 3 : UCIP_SP_2020_56035_47333.jpg

WS view: concrete surge box

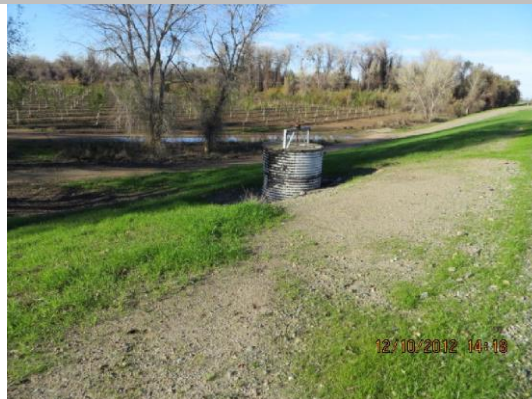
Photo 1 of 3 : UCIP_SP_2020_55576_47343.jpg

DS_ID:17340
FS_ID:55576
EP_NO: 9511
Repair Type: Non-Urgent
Crossing Status: Found
UCIP Comments: 08/01/2019 Crossing remains Non-Urgent; internal inspection shows issues associated with crossing (refer to internal inspection report), pipe has been abandoned, and ABO issued as permit number 9511. Recommend auditing this record to determine current owner and if crossing is no longer in use, the pipe will need to be removed or abandoned per Title 23. Board has been placed on WS outlet to prevent sediment buildup. (O. Magana - DWR UCIP)04/20/2017 Abandoned- needs to be done properly. A oak tree has fallen down onto the WS pipe end. It does not appear to have damaged the pipe but it will need to be better inspected after the tree has been cleared away. (DWR Sutter Yard- A Freitag)10/31/2016 Abandoned. (DWR Sutter Yard- A Freitag)06/14/2016 Pipe was internally cleaned and camera inspected on 11/6/2015 by Nor-Cal Pipeline Services. The 48" cmp pipe section that runs through the levee was deemed to be in good condition. After the LS levee toe the pipe changes to a 48" concrete box culvert for under the roadway and that showed signs of some cracking. After the inspection the WS end was capped to keep sediment out until further abandonment can be achieved.04/16/2016 A wooden board has been placed on WS outlet of pipe to prevent sediment from entering pipe. This is a temporary repair measure by Sutter Yard until pipe can be grouted. Need to contact owner to ensure pipe's proper abandonment. Blockage of pipe outlet by wooden board or sediment will pose a hazard during high water. Pipe owner unclear, as landowner differs on LS and WS.04/02/2015 Pipe has been selected for internal camera inspection.Outlet pipe silted on WS. Inlet structure damaged on LS. Not properly abandoned.07/02/2014 Same as last inspection.12/19/2013 Same as last inspection.07/23/2013 Same as last inspection.

FIELD_STRUCT_DESC: *ABANDONED* 48-inch corrugated metal drainage pipe through the levee, 16.5 feet below the crown. Slide gate in a 60-inch corrugated metal pipe (CMP) riser on the waterside (WS) slope. Landside (LS) end of pipe on east side of River Road. Pipe is not in use but is operable. (48-inch pipe [HLM 13.37] authorized under Permit No. 9511, 1974 - Moresco). [Additional Reference(s): DWR Levee Log, 2002. USACE Sacramento O&M Manual 136, March 1960 (HLM 13.37)].
FS Date: 8/1/2019 1:50:00 PM

WS view: CMP riser with slide gate

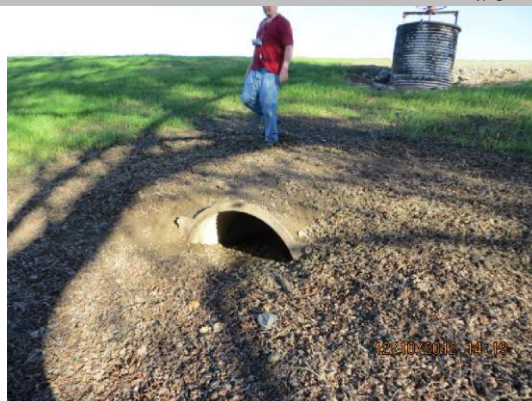
Photo 2 of 3 : UCIP_SP_2020_55576_47342.jpg

WS view: overview of CMP riser and outlet pipe

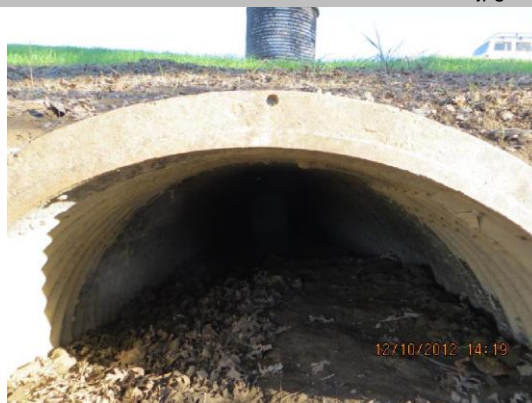
Photo 3 of 3 : UCIP_SP_2020_55576_47341.jpg

WS view: silted concrete lined CMP outlet pipe

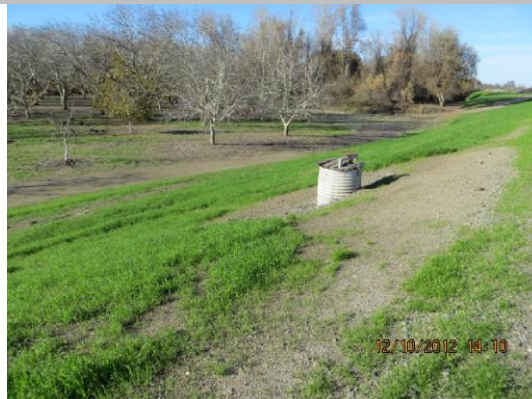
Photo 1 of 3 : UCIP_SP_2020_55577_47349.jpg

DS_ID:17361
FS_ID:55577
EP_NO: N/A
Repair Type: Non-Urgent
Crossing Status: Indicator Found
UCIP Comments: 08/01/2019 Crossing remains Non-Urgent; pipe is abandoned and no permit has been found authorizing this crossing. If crossing is no longer in use, the pipe will need to be removed or abandoned according to Title 23. (O. Magana - DWR UCIP)04/20/2017 Abandoned- needs to be done properly. (DWR Sutter Yard- AFreitag)10/31/2016 Appears abandoned. WS pipe end buried. (DWR Sutter Yard- AFreitag)06/14/2016 WS pipe end was dug up for a internal camera inspection. The WS slide gate was sealed shut and would not open so the inspection was only done form the WS pipe end to the WS slide gate (33.1ft). The pipe showed some signs of heavy rusting but no visible holes or other signs of deterioration were found. After the inspection the WS pipe end was capped and reburied until further abandonment can be achieved.04/02/2015 Only CMP riser on WS. Pipe has been selected for internal camera inspection. Only CMP riser found on WS.07/02/2014 Same as last inspection.12/19/2013 Same as last inspection.07/23/2013 Same as last inspection.

FIELD_STRUCT_DESC: *ABANDONED* 24-inch corrugated metal drainage pipe through the levee, 16 feet below the crown, not found in 2015. Slide gate in a corrugated metal pipe (CMP) riser on the waterside (WS) end, found in 2015. [Additional Reference(s): DWR Levee Log, 2002. USACE Sacramento O&M Manual 136, March 1960 (HLM 13.92)].
FS Date: 8/1/2019 1:50:00 PM

WS view: CMP riser with slide gate

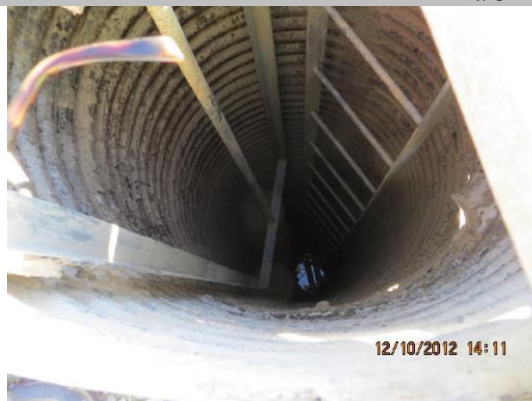
Photo 2 of 3 : UCIP_SP_2020_55577_47348.jpg

WS view: inside CMP riser

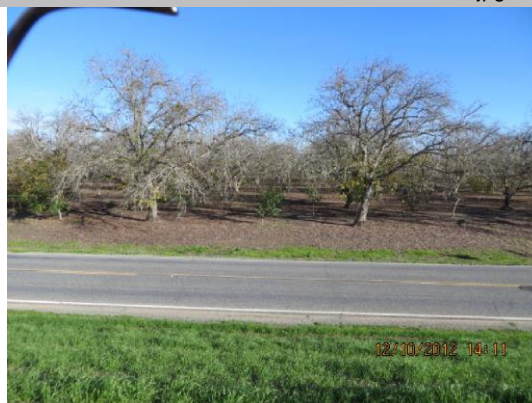
Photo 3 of 3 : UCIP_SP_2020_55577_47347.jpg

LS view: overview- across the county road

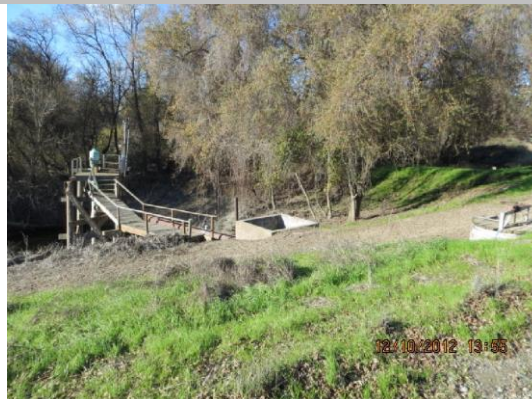
Photo 1 of 3 : UCIP_SP_2020_55578_47352.jpg

DS_ID:17359
FS_ID:55578
EP_NO: 1858
Repair Type: Non-Urgent
Crossing Status: Found
UCIP Comments: 08/01/2019 Crossing has been upgraded from No Action Needed to Non-Urgent due to missing permit authorizing pipe crossing. Permit previously recorded as 1858 is incorrect, permit is for 12KV pole line extension. (O. Magana - DWR UCIP)04/20/2017 Crossing appears to be in good condition. (DWR Sutter Yard- A Freitag)10/31/2016 Crossing appears to be in good condition. (DWR Sutter Yard- A Freitag)06/03/2016 Crossing appears to be in good condition.04/02/2015 Same as last inspection. Pump on wooden pile structure. Concrete surge box on WS. Concrete distribution box on LS.07/02/2014 Same as last inspection.12/19/2013 Pump structure appears to have been rebuilt. Everything else is the same.07/23/2013 Same as last inspection.
FIELD_STRUCT_DESC: 42-inch corrugated metal irrigation pipe through the levee, 12.8 feet below the crown. Vertical pump on a pile structure on the waterside (WS) toe. Slide gate in a corrugated metal pipe (CMP) riser on the WS slope. Concrete surge box on the WS toe. Concrete distribution box on the landside (LS) toe. Service pole on the WS berm. [Additional Reference(s): DWR Levee Log, 2002. USACE Sacramento O&M Manual 136, March 1960 (HLM 14.3)].

WS view: pump, walkway, surge box, & CMP riser

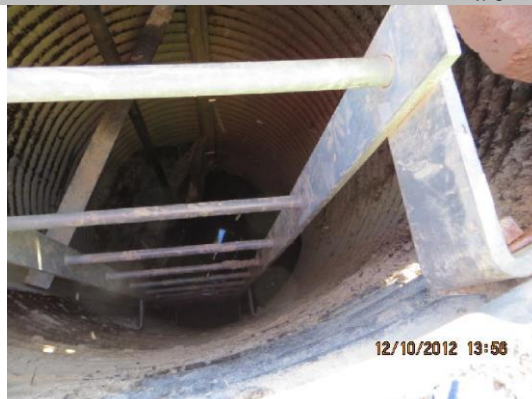
Photo 2 of 3 : UCIP_SP_2020_55578_47351.jpg

WS view: inside CMP riser

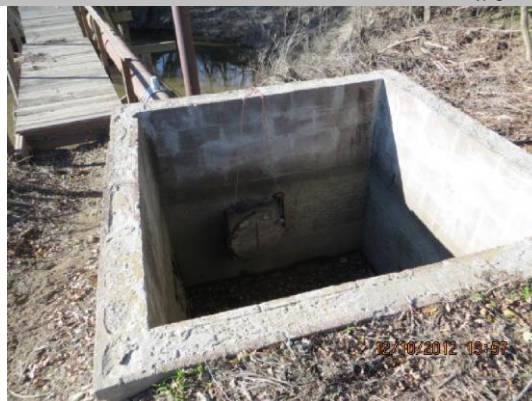
Photo 3 of 3 : UCIP_SP_2020_55578_47350.jpg

WS view: surge box, steel pipe & flap gate

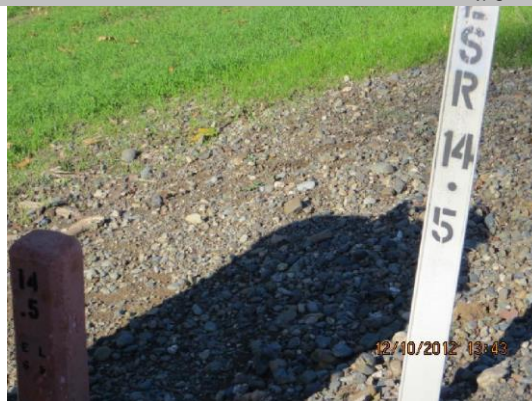
Photo 2 of 3 : UCIP_SP_2020_55579_47361.jpg

WS view: levee mile marker

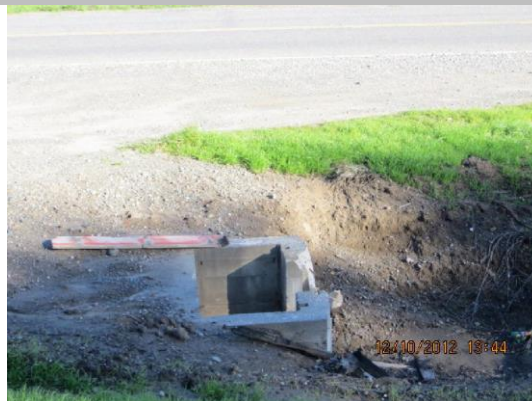
Photo 3 of 3 : UCIP_SP_2020_55579_47360.jpg

LS view: overview of distribution box

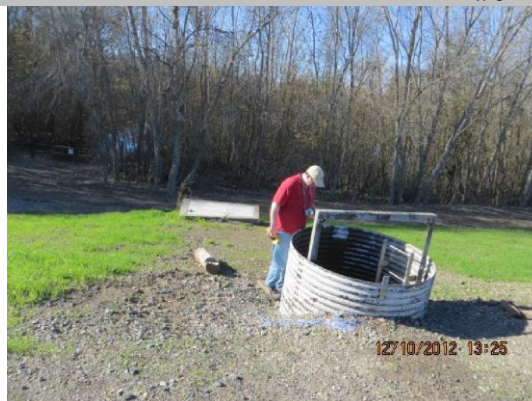
Photo 1 of 3 : UCIP_SP_2020_56036_47363.jpg

DS_ID:17331
FS_ID:56036
EP_NO: 1833
Repair Type: Urgent
Crossing Status: Found
UCIP Comments: 08/01/2019 Crossing has been updated from Non-Urgent to Urgent due to leaky pipe noted back in 2015. 16-inch pipe has been sleeved through the 42-inch which could be the cause for leaky pipe during high water. There appears to be no way to prevent uncontrolled flood water from WS to LS. This crossing has been abandoned but not properly. Need to remove or abandon this pipe per Title 23 requirements. (O. Magana - DWR UCIP)04/20/2017 No leaky pipe marker present during this inspection but it appears that nothing has changed or was repaired since it was labeled leaky in 2015. (DWR Sutter Yard- A Freitag)10/31/2016 Leaky pipe marker was not present at inspection but nothing appears to have changed with this crossing. (DWR Sutter Yard- A Freitag)06/15/2016 No changes made to this crossing. Leaky pipe marker still present.04/14/2016 Levee slightly caved in one side of surge box on WS04/02/2015 Leaks during high water. 07/02/2014 Same as last inspection.12/19/2013 Same as last inspection.07/23/2013 Same as last inspection.12/11/2012 Distribution box plugged with cement concrete on LS. Other concrete box plugged with concrete on WS. New steel pipe (about 16 inch diameter) sleeved through CMP pipe. It is visible inside CMP riser. (P. Amatya - DWR UCIP)

FIELD_STRUCT_DESC: 42-inch corrugated metal irrigation pipe through the levee, 14.2 feet below the crown. 16-inch (approximate) pipe has been sleeved through the 42-inch corrugated metal pipe (CMP), with annular space pressure grouted. Pump structure on the waterside (WS) bank, not found in 2016. Concrete surge box at the WS toe. Slide gate in a CMP riser on the WS slope. Concrete distribution box on the landside (LS) across River Road. Phone number provided is 916-802-8293. (Permit No. 1833, 1953 - Carter). [Additional Reference(s): DWR Levee Log, 2002. USACE Sacramento O&M Manual 136, March 1960 (HLM 14.55)].
FS Date: 8/1/2019 1:52:00 PM

WS view: CMP riser with slide gate and surge box

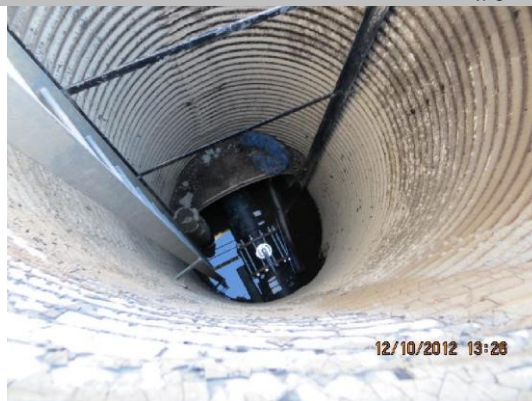
Photo 2 of 3 : UCIP_SP_2020_56036_47362.jpg

WS view: new steel pipe sleeved through CMP pipe.

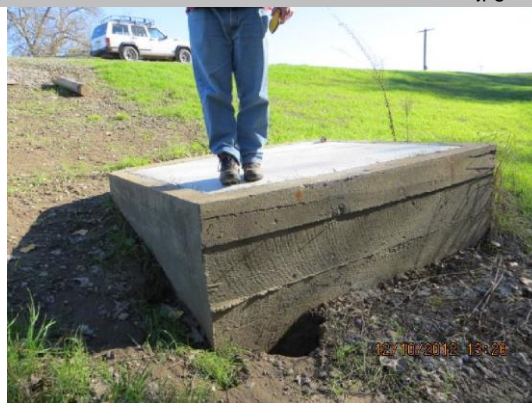
Photo 3 of 3 : UCIP_SP_2020_56036_47366.jpg

WS view: plugged concrete surge box

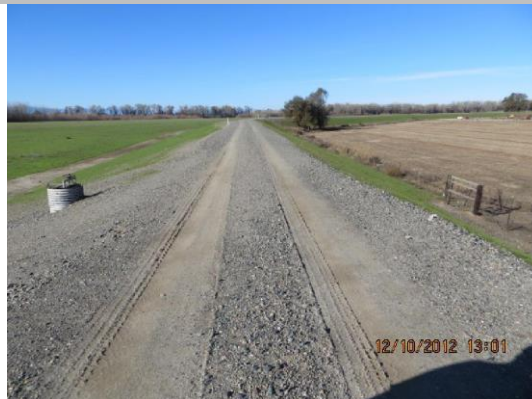
Photo 1 of 3 : UCIP_SP_2020_55586_47371.jpg

DS_ID:17333
FS_ID:55586
EP_NO: 9506
Repair Type: Non-Urgent
Crossing Status: Found
UCIP Comments: 08/01/2019 Crossing remains Non-Urgent; record need to be audited to correct ABO issued as permit number 9506. (O. Magana - DWR UCIP)04/20/2017 Both pipe ends were underwater during site visit but it appears to be in good condition. (DWR Sutter Yard- A Freitag)10/31/2016 Minor erosion caused by rain runoff starting at the top of the WS headwall. Rest of crossing appears in good condition. (DWR Sutter Yard- A Freitag)06/15/2016 Both pipe ends were underwater but appear to be in good condition.04/02/2015 Pipe and ditches were full of water. Everything seemed to be in good shape.07/02/2014 Same as last inspection.12/19/2013 Same as last inspection.07/23/2013 Same as last inspection.12/11/2012 Water full on inlet and outlet of the structure. (P. Amatya - DWR UCIP) FIELD_STRUCT_DESC: 24-inch irrigation pipe of an unknown material through the levee, 16.5 feet below the crown. Pump in the floodway. Irrigation transfer ditch on the waterside (WS) to concrete surge box at the WS toe. Slide gates in a corrugated metal pipe (CMP) riser on the WS slope. Discharges into a concrete distribution box at the landside (LS) toe. (Automatic Board Order (ABO) issued as Permit No. 9506, 1974 - Carter). [Additional Reference(s): DWR Levee Log, 2002. USACE Sacramento O&M Manual 136, March 1960 (HLM 15.46)]. FS Date: 8/1/2019 1:54:00 PM

Crown view: overview (both sides of the levee)

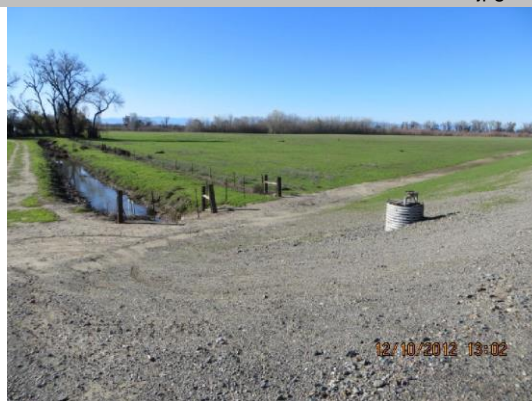
Photo 2 of 3 : UCIP_SP_2020_55586_47370.jpg

WS view: CMP riser, inlet box and water transfer ditch

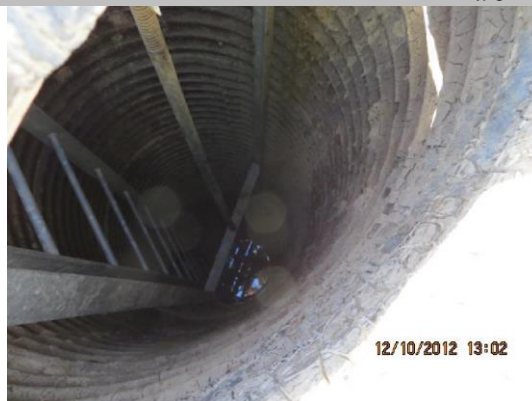
Photo 3 of 3 : UCIP_SP_2020_55586_47369.jpg

WS view: inside CMP riser

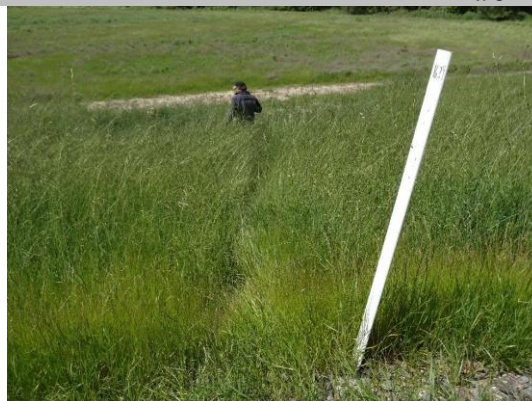
Photo 1 of 3 : UCIP_SP_2020_55591_75096.jpg

DS_ID:17337
FS_ID:55591
EP_NO: N/A
Repair Type: Non-Urgent
Crossing Status: Found
UCIP Comments: 08/05/2019 Crossing remains Non-Urgent, pipe remains abandoned. No permit has been found authorizing pipe. Internal inspection was completed in 2015; refer to internal inspection report and notes recorded during 06-15-16 inspection. Internal inspection report only noted a sag in the pipe at about 33.5 feet from LS going to WS. Pipe was opened for internal inspection but inlet/outlet were closed/buried again. Recommend LMA prepare a contingency plan for increased inspections during high-water to identify any pipe integrity or levee integrity issues that might arise with abandoned pipe. (O. Magana - DWR UCIP)04/20/2017 Abandoned- needs to be done so properly. (DWR Sutter Yard- A Freitag)11/01/2016 Abandoned. Pipe is buried and not visible but a white marker on WS shoulder shows its location. (DWR Sutter Yard- A Freitag)06/15/2016 Pipe was dug up and internally cleaned and camera inspected on 11/19/2015 by Nor-Cal Pipeline Services. Pipe section through the levee is 88ft long and showed signs of rusting but no holes or other deterioration was found. The WS flap gate was broken during excavation but doesn't pose an issue as the pipe was capped and reburied until further abandonment can be achieved. Unfortunately the pipe was not photographed when exposed.04/14/2016 Same as last inspection.04/02/2015 Unable to locate. Pipe has been selected to be dug up and internally camera inspected.07/02/2014 Unable to locate.12/19/2013 Unable to locate.07/23/2013 Same as last inspection. Unable to locate.

FIELD_STRUCT_DESC: 42-inch corrugated metal drainage pipe through the levee, 16.5 feet below the crown. Metal flap gate on the waterside (WS) silted over. Brick "U" shaped headwall on the WS toe. [Additional Reference(s): DWR Levee Log, 2002. USACE Sacramento O&M Manual 136, March 1960 (HLM 16.29)].
FS Date: 8/5/2019 2:23:00 PM

View from crown down WS slope at location of crossing.

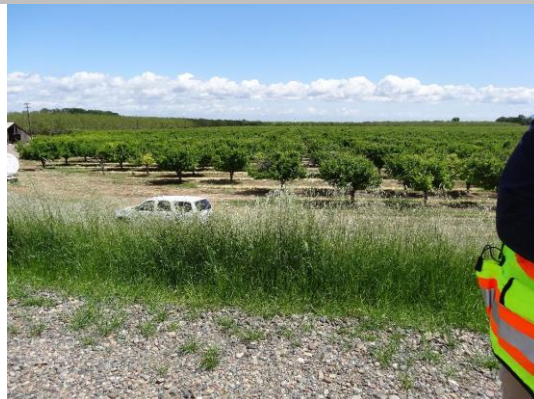
Photo 2 of 3 : UCIP_SP_2020_55591_75097.jpg

View of LS from crown at location of crossing.

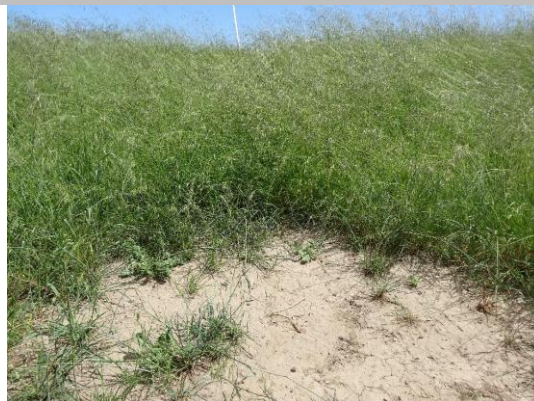
Photo 3 of 3 : UCIP_SP_2020_55591_75098.jpg

Looking up WS slope: bare spot where pipe was previously excavated, video inspected, and backfilled.

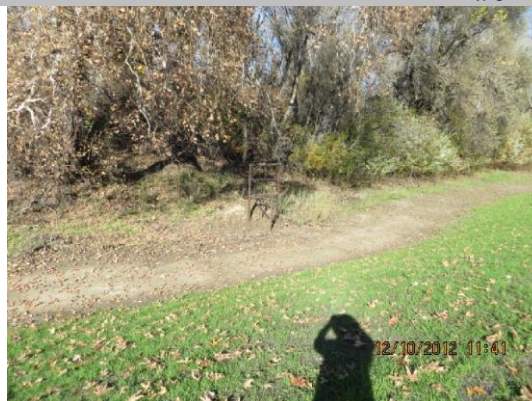
Photo 1 of 3 : UCIP_SP_2020_55593_47380.jpg

| DS_ID:17349 FS_ID:55593 EP_NO: 9500 Repair Type: Non-Urgent Crossing Status: Indicator Found UCIP Comments: 08/05/2019 Crossing remains Non-Urgent; crossing has been abandoned. Recommend auditing records to resolve ABO issued as permit number 9500. Pipe on the WS has been buried. (O. Magana - DWR UCIP)04/20/2017 Abandoned- needs to be done properly. (DWR Sutter Yard- A Freitag)11/01/2016 Abandoned. (DWR Sutter Yard- A Freitag)06/15/2016 Abandoned- WS slide gate and LS distribution box are silted over.04/16/2016 Same as last inspection. Appears abandoned and should be done so properly.04/02/2015 WS slide gate and LS distribution box are still silted over.07/02/2014 Same as last inspection.12/19/2013 Same as last inspection.07/23/2013 Same as last inspection.12/11/2012 Seems abandoned as slide gate and distribution box silted. (P. Amatya - DWR UCIP) FIELD_STRUCT_DESC: *ABANDONED* 48-inch corrugated metal irrigation and drainage pipe through the levee, 17 feet below the crown, not found in 2016. Slide gate on the waterside (WS), found in 2016. 8-inch steel pipe sleeved through the 48-inch pipe during the summer months, not found in 2016. Discharges into a concrete distribution box on the landside (LS) toe. (Automatic Board Order (ABO) issued as Permit No. 9500, 1974 - Zumwalt Orchards, Inc.). [Additional Reference(s): DWR Levee Log, 2002. USACE Sacramento O&M Manual 136, March 1960 (HLM 16.42)]. FS Date: 8/5/2019 2:26:00 PM | | | | | | |

WS view: overview of slide gate

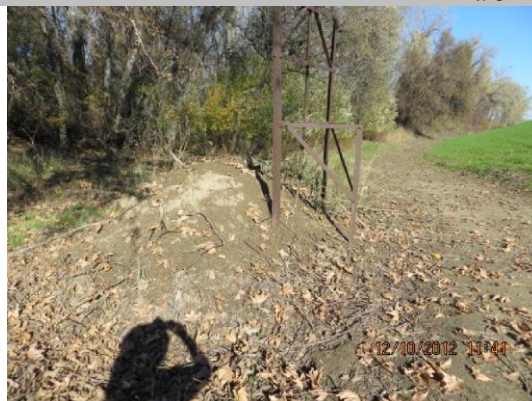
Photo 2 of 3 : UCIP_SP_2020_55593_47379.jpg

WS view: slide gate on steel structure

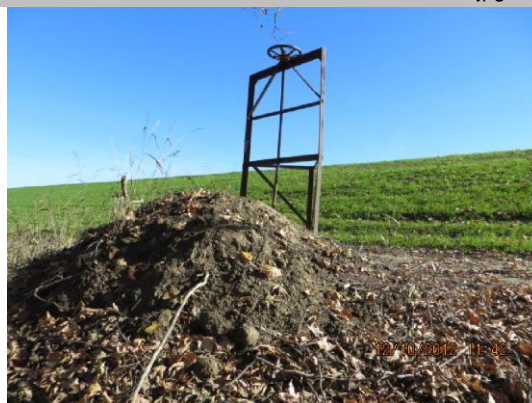
Photo 3 of 3 : UCIP_SP_2020_55593_47378.jpg

WS view: silt and debris in front of slide gate

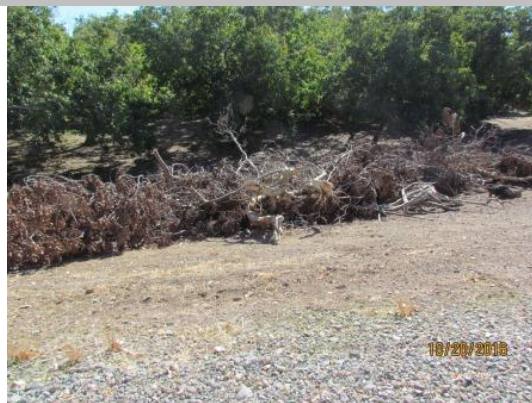
Photo 1 of 1 : SP_2020_ST0003_264_68_20200226_00011.jpg

View of the prunings along the landside toe.

| Remove prunings from the landside toe. | | | | | |

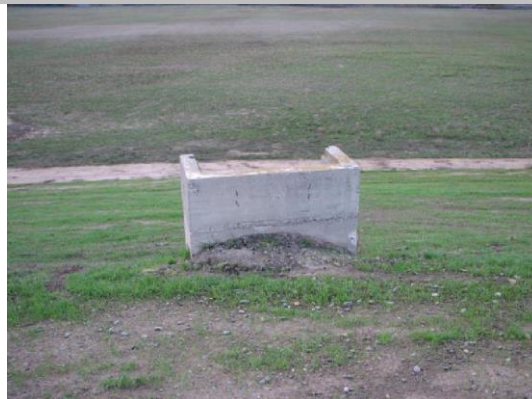
Photo 1 of 3 : UCIP_SP_2020_55595_47383.jpg

| DS_ID:17339 FS_ID:55595 EP_NO: N/A Repair Type: Non-Urgent Crossing Status: Indicator Found UCIP Comments: 08/05/2019 Culvert has been upgraded from No Action Needed to Non-Urgent, culvert has been abandoned through the levee. DWR DMP geophysical investigation report did not find any signs of metal crossing through the levee. Culvert will remain in UCIP's list until a future levee improvement project can confirm culvert through levee. This culvert will remain in the inspection list and will need to be monitored in case any integrity issues with the levee arise. (O. Magana - DWR UCIP)04/20/2017 Abandoned- needs to be done properly. A new survey stake was placed at the WS shoulder above the pipe alignment with "MBK 1" written on it. Not sure of its purpose. (DWR Sutter Yard- A Freitag)11/01/2016 Abandoned/plugged. (DWR Sutter Yard- A Freitag)06/15/2016 WS end was dug up in November 2015 and verified that the concrete plug is in place.04/02/2015 Only WS concrete headwall was found. Pipe has been selected to be dug up and internally camera inspected. Abandoned concrete structure found on waterside and concrete debris found on landside of the levee.07/02/2014 Same as last inspection.12/19/2013 Same as last inspection.07/24/2013 Same as last inspection. FIELD_STRUCT_DESC: *ABANDONED* 36-inch by 60-inch reinforced concrete box drainage culvert through the levee, 20.5 feet below the crown. Waterside (WS) end of the pipe is plugged with concrete for 5 feet. Landside (LS) end of the culvert was filled with dirt in 1980. [Additional Reference(s): DWR Levee Log, 2002. USACE Sacramento O&M Manual 136, March 1960 (HLM 17.3)]. FS Date: 8/5/2019 2:27:00 PM | | | | | | |

WS view: overview of abandoned/damaged concrete structure

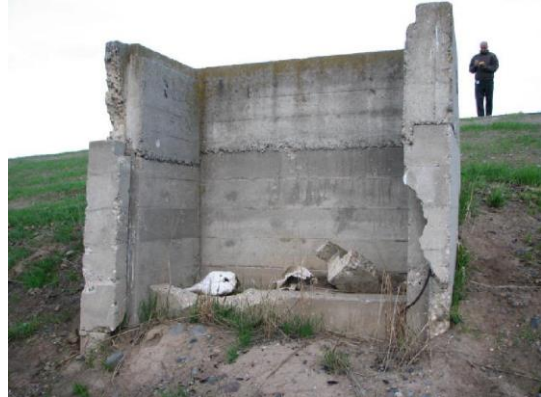
Photo 2 of 3 : UCIP_SP_2020_55595_47382.jpg

WS view: closer view of the concrete structure

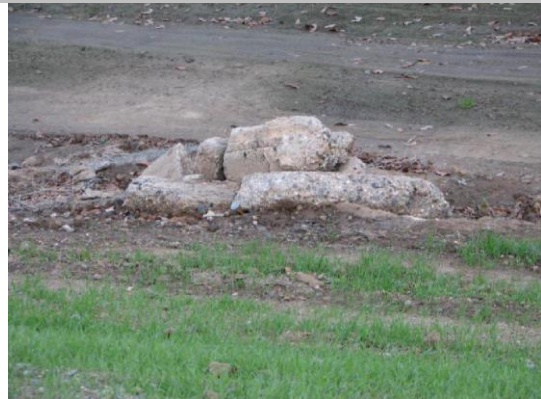
Photo 3 of 3 : UCIP_SP_2020_55595_47381.jpg

LS view: remains of concrete structure

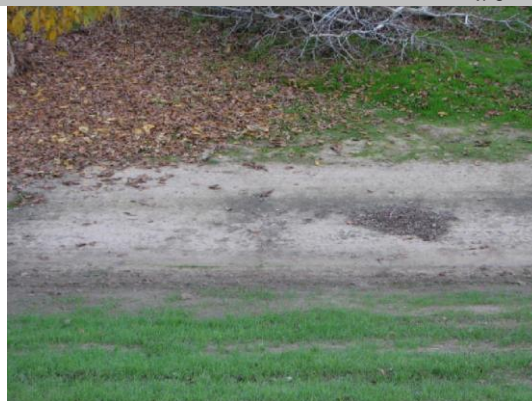
Photo 1 of 3 : UCIP_SP_2020_55599_47384.jpg

DS_ID:17329
FS_ID:55599
EP_NO: N/A
Repair Type: Urgent
Crossing Status: Found
UCIP Comments: 08/05/2019 Crossing has been updated from Non-Urgent to Urgent due to leak observed in 2017 during high water. The appears to be a leak that could be caused by the screw gate not fully closed allowing water from the WS to LS. No permit has been found authorizing the crossing. If crossing is no longer in use, owner will need to remove or abandon properly per Title 23 requirements. Slide gate width measures 36 inches and not the 24 inches that is needed for the 24-inch pipe. (O. Magana - DWR UCIP)04/20/2017 Abandoned-needs to be done properly. Pipe had a small leak during high water and is believed to be caused by the screw gate not being fully closed before it was reburied after its internal inspection. (DWR Sutter Yard-AFreitag)11/01/2016 Abandoned. (DWR Sutter Yard-AFreitag)06/15/2016 Pipe was dug up and internally cleaned and camera inspected on 11/18/2015 by Nor-Cal Pipeline Services. Pipe section through levee is about 93.8ft long. Inspection showed signs of rusting but no holes or other deterioration was found. WS end and slide gate were photographed, LS end was not. After the inspection pipe ends were capped and reburied until further abandonment can be achieved.04/02/2015 WS pipe end was dug up in preparation for internal camera inspection. Only steel slide gate structure found on waterside.07/02/2014 Same as last inspection.12/19/2013 Same as last inspection.07/24/2013 Same as last inspection.

FIELD_STRUCT_DESC: *ABANDONED* 24-inch corrugated metal drainage pipe through the levee, 15.8 feet below the crown. Slide gate on the waterside (WS) end. Both pipe ends are silted over. [Additional Reference(s): DWR Levee Log, 2002. USACE Sacramento O&M Manual 136, March 1960 (HLM 17.6)].
FS Date: 8/5/2019 2:29:00 PM

LS view: overview. No pipe found.

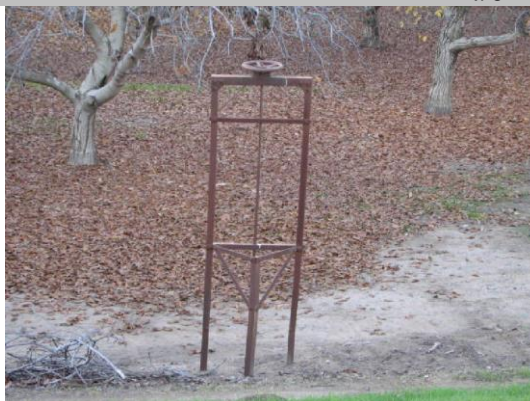
Photo 2 of 3 : UCIP_SP_2020_55599_47386.jpg

WS view: slide gate steel structure

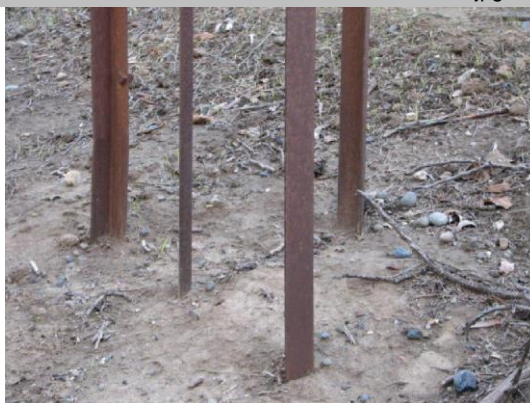
Photo 3 of 3 : UCIP_SP_2020_55599_47385.jpg

WS view: buried slide gate

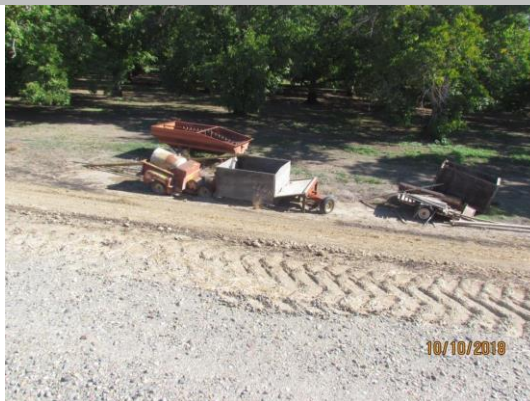
Photo 1 of 1 : SP_2020_ST0003_264_96_20200226_00016.jpg

View of the equipment along the landside toe.

| Remove equipment from the landside toe. | | | | | |

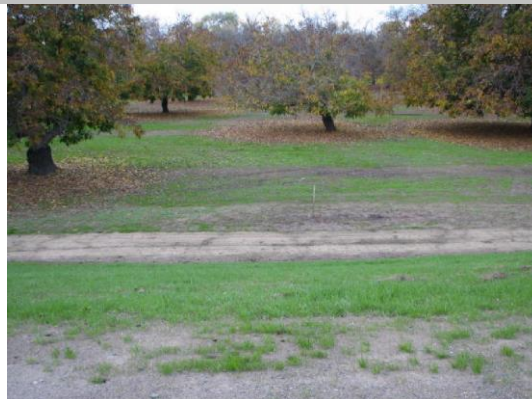
Photo 1 of 3 : UCIP_SP_2020_55600_47387.jpg

DS_ID:17341
FS_ID:55600
EP_NO: 11540A
Repair Type: Non-Urgent
Crossing Status: Indicator Found
UCIP Comments: 08/05/2019 Crossing has been updated from No Action Needed to Non-Urgent due to modifications observed on the LS and WS toe. New elbow valve has been installed on the WS toe (2016). Need to contact owner to determine maintenance records of line through the levee. (O. Magana - DWR UCIP)04/20/2017 Crossing appears to be in good condition. (DWR Sutter Yard- A Freitag)11/01/2016 Crossing appears to be in good condition. (DWR Sutter Yard- A Freitag)06/03/2016 Landside pump set was running and water was bubbling from the LS shoulder siphon breaker so the pump set is definitely tied to this crossing. A new elbow valve was also found near the WS toe.04/02/2015 Same as last inspection. Only found a siphon breaker on landside and a valve in waterside. A pumping set found on LS, not sure if it belongs to this crossing.07/02/2014 Same as last inspection.12/19/2013 Same as last inspection.07/24/2013 Same as last inspection.

WS view: overview

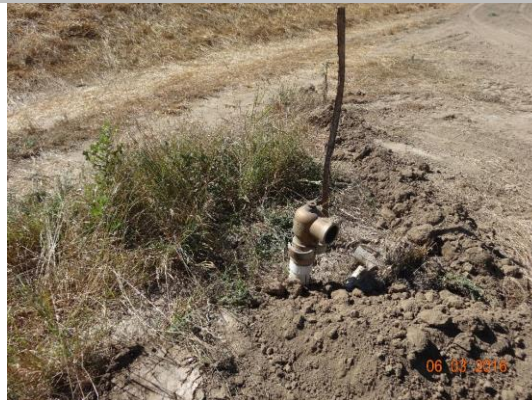
Photo 2 of 3 : UCIP_SP_2020_55600_75228.jpg

Elbow valve near WS levee toe

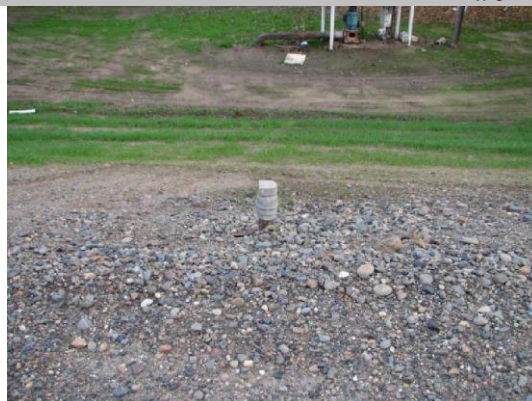
Photo 3 of 3 : UCIP_SP_2020_55600_47388.jpg

LS view: overview of siphon breaker and pump

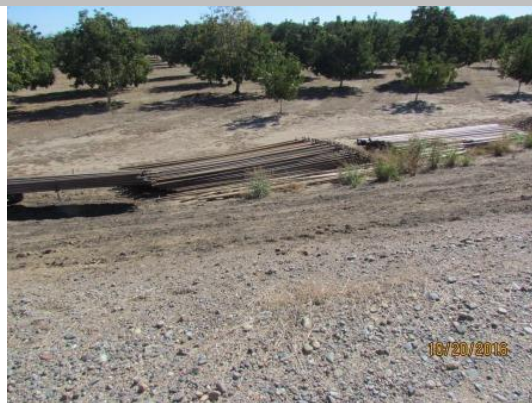
Photo 1 of 1 : SP_2020_ST0003_264_63_20200226_00008.jpg

View of the materials along the landside toe.

| Remove materials from the landside toe. | | | | | |

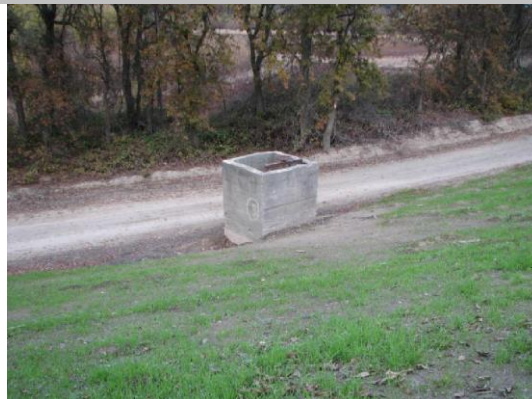
Photo 1 of 3 : UCIP_SP_2020_55604_47394.jpg

DS_ID:17343
FS_ID:55604
EP_NO: 9502
Repair Type: Non-Urgent
Crossing Status: Found
UCIP Comments: 08/05/2019 Crossing remains Non-Urgent, crossing has been abandoned. Owner will need to work with the CVFPB to remove or abandon the crossing per Title 23 requirements. Need to audit this record to confirm ABO issued as permit number 9502 and permit number 11540 are still valid for 36-inch pipe. Unable to confirm if 36-inch pipe has been abandoned properly. Permit records indicate pumping plant and discharge pipe, 36-inch pipe, through the levee was suppose to be abandoned or removed. Per special condition TWENTY: That the abandoned pipe shall be completely filled with grout under pressure within the levee section in accordance with Reclamation Board Standards and TWENTY-ONE: that all appurtenances, other than the 36-inch diameter, at the site of the abandoned pumping plant shall be removed from the levee section. However, permit records (page 6 of 29) dated October 1976 indicate that applicant planned to continue using the existing pump plan and 36-inch discharge line during the winter months. (O. Magana - DWR UCIP)04/20/2017 Abandoned-needs to be done properly. (DWR Sutter Yard- A Freitag)11/01/2016 Abandoned. (DWR Sutter Yard- A Freitag)06/03/2016 Abandoned crossing.04/02/2015 Same as last inspection. Vertical pump on bank not found as bank is not accessible. An abandoned electrical switch found on waterside. Landside distribution box is filled with debris and soil. Crossing appears abandoned and should be verified as having been done so properly. 07/02/2014 Same as last inspection.12/19/2013 Same as last inspection.07/24/2013 Same as last inspection.

FIELD_STRUCT_DESC: *ABANDONED* 36-inch corrugated metal irrigation pipe through the levee, 18 feet below the crown. Vertical pump on the waterside (WS) bank, not found in 2015. Slide gate in a concrete box on the WS toe. Pipe discharges into a concrete distribution box on the landside (LS) toe. Pole on the WS shoulder and an abandoned electrical switch found on the WS. (36-inch pipe authorized under Automatic Board Order (ABO) issued as Permit No. 9502, 1974 - Coffman; existing 36-inch was allowed to be used during winter months under Permit No. 11540, 1976 - Wilearlee Walnuts). [Additional Reference(s): DWR Levee Log, 2002. USACE Sacramento O&M Manual 136, March 1960 (HLM 18.22)].
FS Date: 8/5/2019 2:38:00 PM

WS view: overview of gate riser

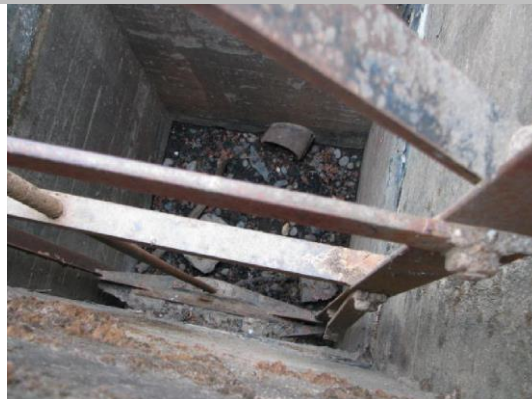
Photo 2 of 3 : UCIP_SP_2020_55604_47392.jpg

WS view: inside gate riser

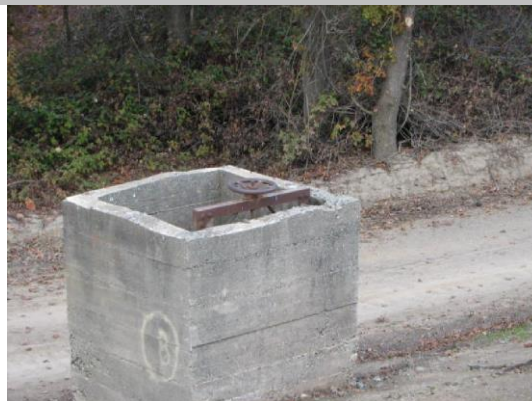
Photo 3 of 3 : UCIP_SP_2020_55604_47391.jpg

WS view: concrete gate riser

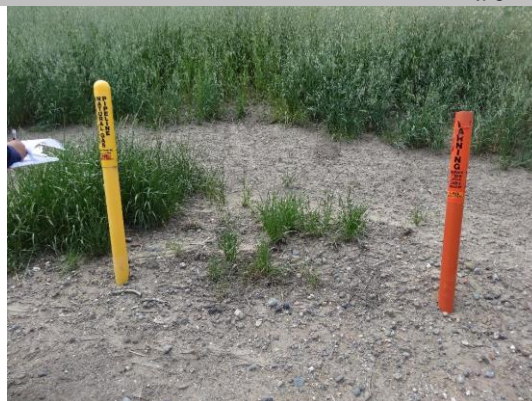
Photo 1 of 3 : UCIP_SP_2020_55606_75210.jpg

| DS_ID:25451 FS_ID:55606 EP_NO: N/A Repair Type: Non-Urgent Crossing Status: Indicator Found UCIP Comments: 08/05/2019 Crossing has been upgraded from No Action Needed to Non-Urgent, no permit has been found authorizing crossing through the levee. Need to contact owner to determine alignment of line, obtain maintenance records, and obtain permit issued authorizing crossing. (O. Magana - DWR UCIP)04/20/2017 Still unsure if this pipe just follows the road way or crosses through the levee. (DWR Sutter Yard- AFreitag)11/01/2016 Crossing appears to be in good condition. Still unknown if it crosses through the levee. (DWR Sutter Yard- AFreitag)04/14/2016 Unsure if pipe crosses levee. FIELD_STRUCT_DESC: Natural gas line of unknown depth, diameter, and material, possibly through the levee. Yellow gas line marker found on landside (LS) toe with phone number on marker: 1-866-940-7351 (Wild Goose Storage). See DSID 25452 for fiber optics cable marker adjacent to this marker. FS Date: 8/5/2019 2:41:00 PM | | | | | | |

LS toe: yellow gas line marker found.

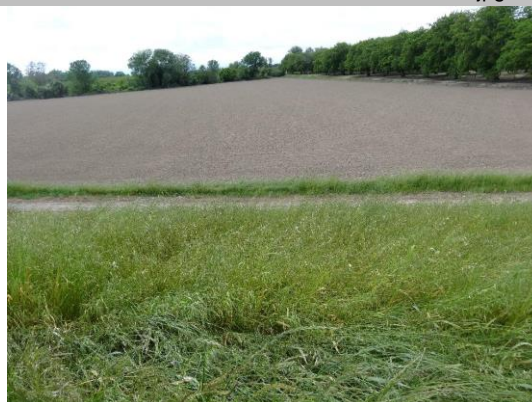
Photo 2 of 3 : UCIP_SP_2020_55606_75211.jpg

View of waterside (WS) from crown, along alignment with gasline marker.

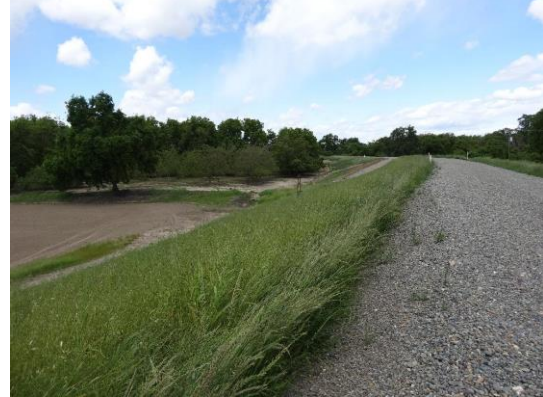
Photo 3 of 3 : UCIP_SP_2020_55606_75212.jpg

Looking upstream at WS slope from crown.

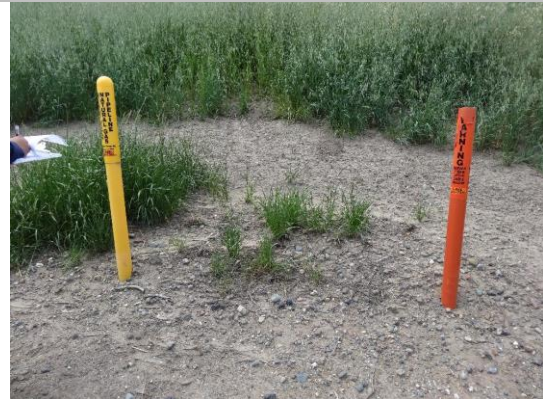
Photo 1 of 3 : UCIP_SP_2020_55607_75215.jpg

LS toe: red fiber optics cable marker found.

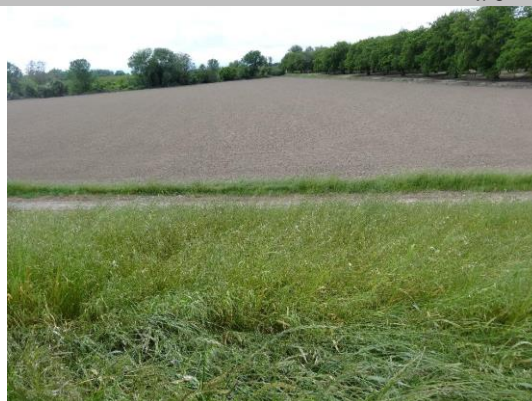
Photo 2 of 3 : UCIP_SP_2020_55607_75216.jpg

View of waterside (WS) from crown, along alignment with fiber optics cable marker.

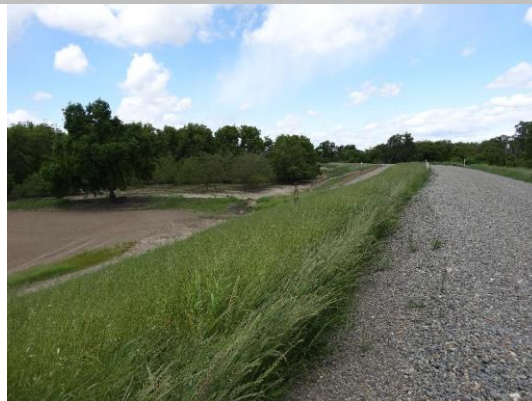
Photo 3 of 3 : UCIP_SP_2020_55607_75217.jpg

Looking upstream at WS slope from crown.

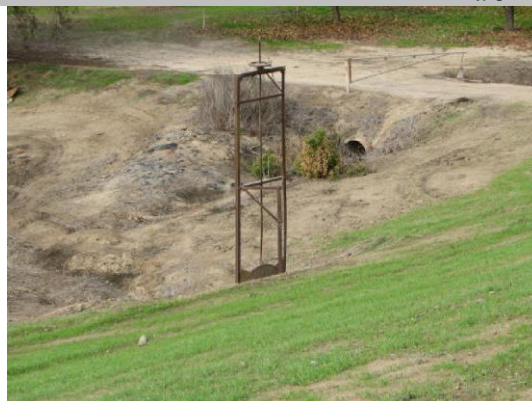
Photo 1 of 3 : UCIP_SP_2020_55610_47399.jpg

FIELD_STRUCT_DESC: 36-inch corrugated metal drainage pipe through the levee, 20 feet below the crown. Slide gate at the waterside (WS) toe. [Additional Reference(s): DWR Levee Log, 2002. USACE Sacramento O&M Manual 136, March 1960 (HLM 18.65)].
FS Date: 8/5/2019 2:43:00 PM

WS view: overview of sliding gate structure

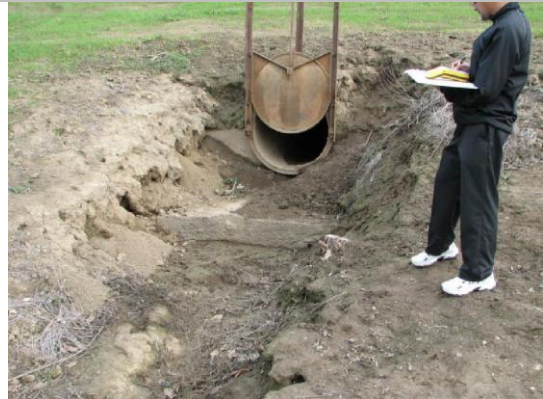
Photo 2 of 3 : UCIP_SP_2020_55610_47398.jpg

WS view: outlet pipe with concrete headwall and floor apron.

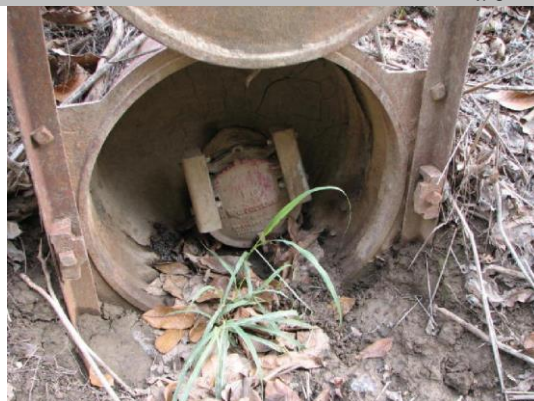
Photo 2 of 3 : UCIP_SP_2020_55611_47441.jpg

WS view: 8-inch pipe inside 24-inch CMP

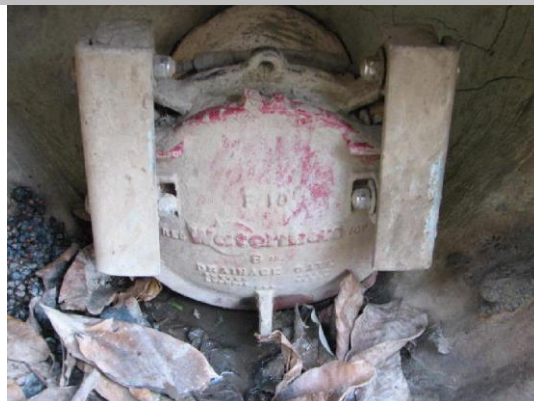
Photo 3 of 3 : UCIP_SP_2020_55611_47440.jpg

WS view: 8-inch pipe and drain gate

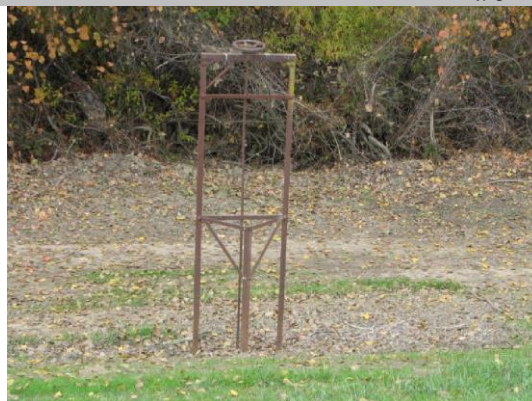
Photo 1 of 3 : UCIP_SP_2020_55616_47447.jpg

WS view: overview of abandoned slide gate structure

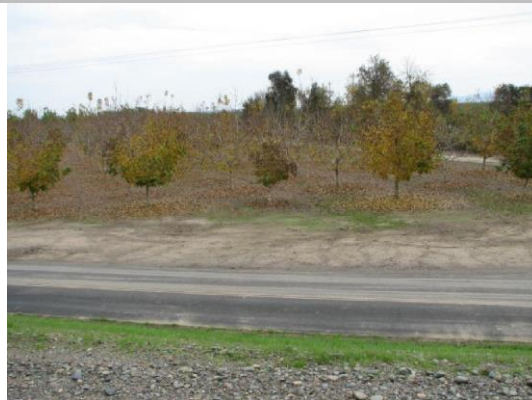
Photo 2 of 3 : UCIP_SP_2020_55616_47446.jpg

LS view: overview (no pipes)

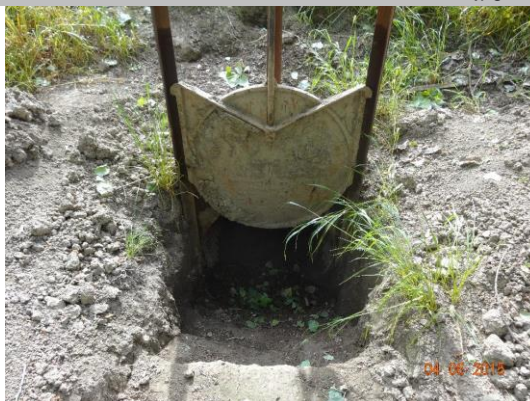
Photo 3 of 3 : UCIP_SP_2020_55616_73781.jpg

WS pipe end and screw gate

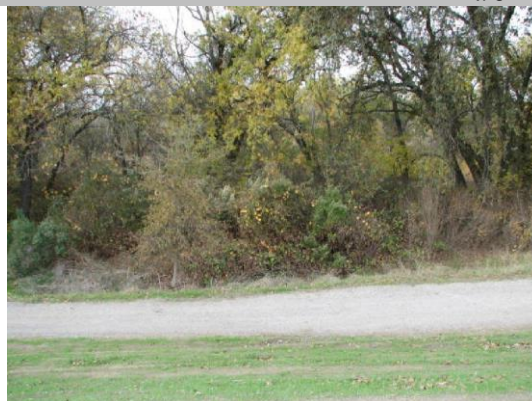
Photo 1 of 3 : UCIP_SP_2020_56037_47449.jpg

DS_ID:17487
FS_ID:56037
EP_NO: N/A
Repair Type: Urgent
Crossing Status: Found
UCIP Comments: 08/05/2019 Crossing has been upgraded from Non-Urgent to Urgent due to photos taken in 2012 that show deteriorated pipe on the WS. Unable to complete thorough inspection due to dense vegetation on the WS. No permit has been identified authorizing crossing. Crossing has been abandoned, if crossing is no longer used owner will need to coordinate with the CVFPB to remove or abandon according to Title 23 requirements. (O. Magana - DWR UCIP)04/20/2017 Abandoned- needs to be done so properly. (DWR Sutter Yard- A Freitag)11/01/2016 Abandoned.(DWR Sutter Yard- A Freitag)06/03/2016 Abandoned crossing.04/02/2015 Same as last inspection. 07/02/2014 Same as last inspection.12/19/2013 Same as last inspection.07/24/2013 Same as last inspection.12/11/2012 Slide Gate WS not found. An abandoned pump and steel pipe found on WS. A 6 ft x 8 ft concrete distribution box with a CMP found on LS. Box filled with soil. An abandoned crossing. (P. Amatya - DWR UCIP) FIELD_STRUCT_DESC: *ABANDONED* 36-inch corrugated metal drainage pipe through the levee, invert 21.7 feet below the crown. Abandoned pump and steel pipe found on the waterside (WS). 6 foot by 8 foot concrete distribution box with the 36-inch corrugated metal pipe found on the landside (LS). [Additional Reference(s): USACE Sacramento O&M Manual 136, March 1960 (HLM 19.61)].

WS view: overview

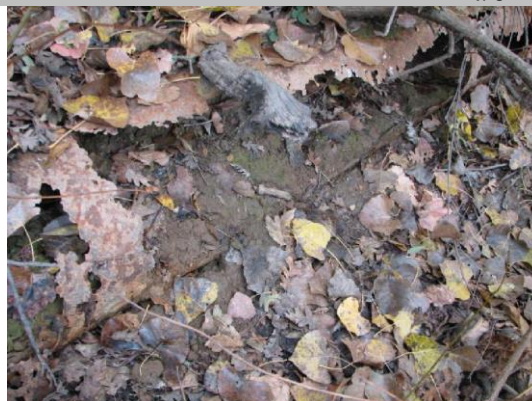
Photo 3 of 3 : UCIP_SP_2020_56037_47453.jpg

WS view: abandoned and ruined pipe

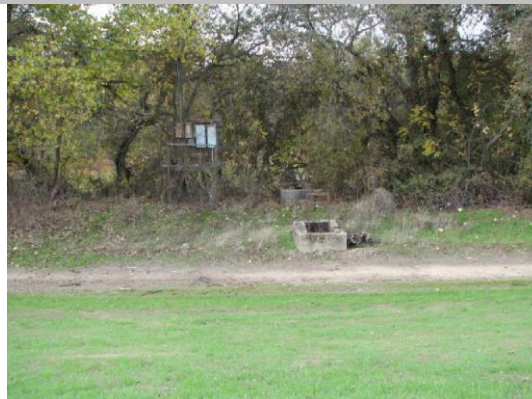
Photo 1 of 3 : UCIP_SP_2020_55621_47459.jpg

DS_ID:17370
FS_ID:55621
EP_NO: 9496
Repair Type: Non-Urgent
Crossing Status: Found
UCIP Comments: 08/05/2019 Crossing remains Non-Urgent, pipe has been abandoned. Need to audit this record to confirm ABO issued as permit number 9496 is still valid for current structure. Limited access on the WS. If crossing is no longer in use, owner will need to coordinate with the CVFPB to remove or abandon crossing according to Title 23 requirements. (O. Magana - DWR UCIP)04/20/2017 Abandoned-needs to be done properly. (DWR Sutter Yard- AFreitag)11/01/2016 Abandoned. (DWR Sutter Yard- AFreitag)06/03/2016 Abandoned crossing04/02/2015 Same as last inspection. Only one pump found on WS. An abandoned surge box found on WS and pipe is grouted with cement. Two 16-inch steel pipe found on pump station along with two electrical conduits. A concrete distribution box found on LS with 20-inch CMP. Appears abandoned crossing.07/02/2014 Same as last inspection.12/19/2013 Same as last inspection.07/24/2013 Same as last inspection.

FIELD_STRUCT_DESC: *ABANDONED* 20-inch corrugated metal irrigation pipe through the levee, 19.8 feet below the crown. (Not 24-inch pipe, as stated in the O&M Manual, Automatic Board Order, and Levee Log). Two vertical pumps on a pile structure on the waterside (WS) bank (one pump found in 2015). Slide gate in a concrete surge box on the waterside (WS) berm. Discharges into a concrete distribution box on the landside (LS) across the county road. Switch board on the platform on the WS bank. (Automatic Board Order (ABO) issued as Permit No. 9496, 1974 - Womble). [Additional Reference(s): DWR Levee Log, 2002. USACE Sacramento O&M Manual 136, March 1960 (HLM 20.05)].
FS Date: 8/5/2019 3:12:00 PM

WS view: overview

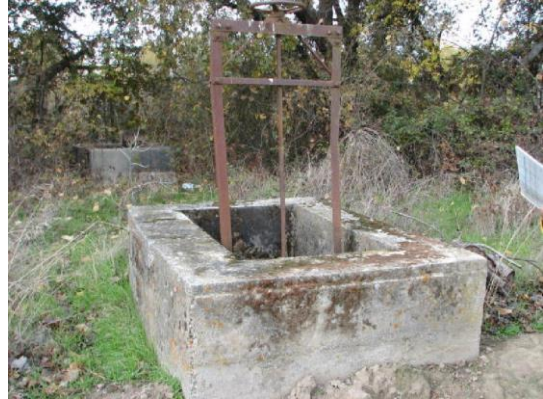
Photo 2 of 3 : UCIP_SP_2020_55621_47457.jpg

WS view: gate riser with slide gate

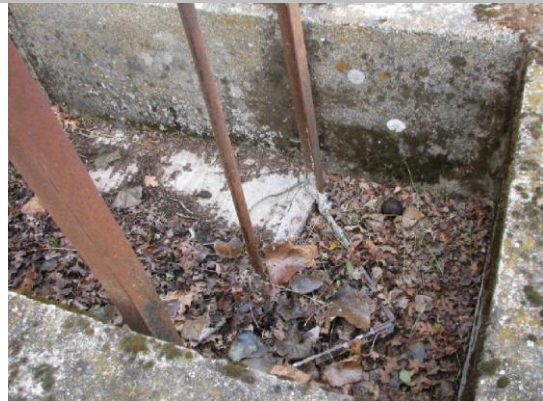
Photo 3 of 3 : UCIP_SP_2020_55621_47456.jpg

WS view: abandoned pipe with cement grouting

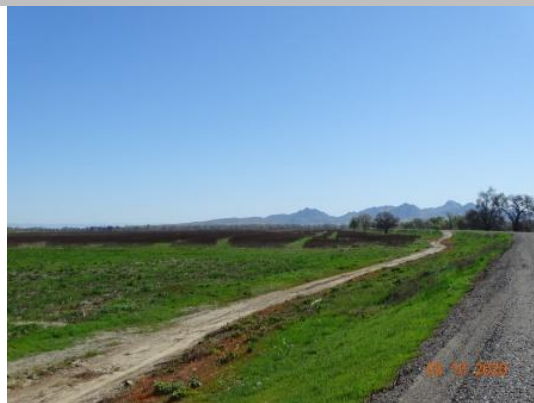
Photo 1 of 1 : SP_2020_ST0003_265_8_20200313_00014.jpg

| Good vegetation control for both landside and waterside slopes. | | | | | |

View of the vegetation on the waterside slope. Spring 2020.

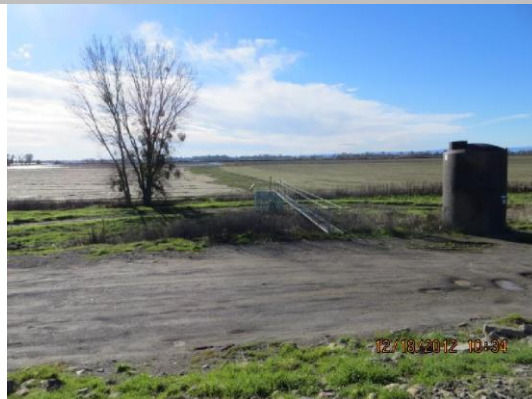
Photo 1 of 3 : UCIP_SP_2020_55624_47476.jpg

DS_ID:17532
FS_ID:55624
EP_NO: 15821
Repair Type: Non-Urgent
Crossing Status: Indicator Found
UCIP Comments: 08/05/2019 Crossing has been updated from No Action Needed to Non-Urgent; need maintenance records to determine current status of line. Recommend auditing this record to confirm authorized lines through the levee and appurtenances associated with line. (O. Magana - DWR UCIP)06/03/2016 Crossing appears to be in good condition.04/06/2015 Same as last inspection.07/07/2014 Same as last inspection.12/19/2013 Same as last inspection.07/22/2013 Same as last inspection.
FIELD_STRUCT_DESC: 1 of 3. 4-inch natural gas pipeline under both levees. 12-inch distance between the pipes and two inches on either side of the trench. A gas line marker found on the landside (LS) for all 3 gas lines. (Permit No. 15821, 1991 - Phoenix Oil & Gas).
FS Date: 8/5/2019 3:18:00 PM

LS view: overview
